July 1996
NSRP 0471

Evaluation of New Surface Preparation and Coating Repair Techniques in Ballast Tanks - Phase III

U.S. DEPARTMENT OF THE NAVY
CARDEROCK DIVISION,
NAVAL SURFACE WARFARE CENTER

in cooperation with
Peterson Builders, Inc.

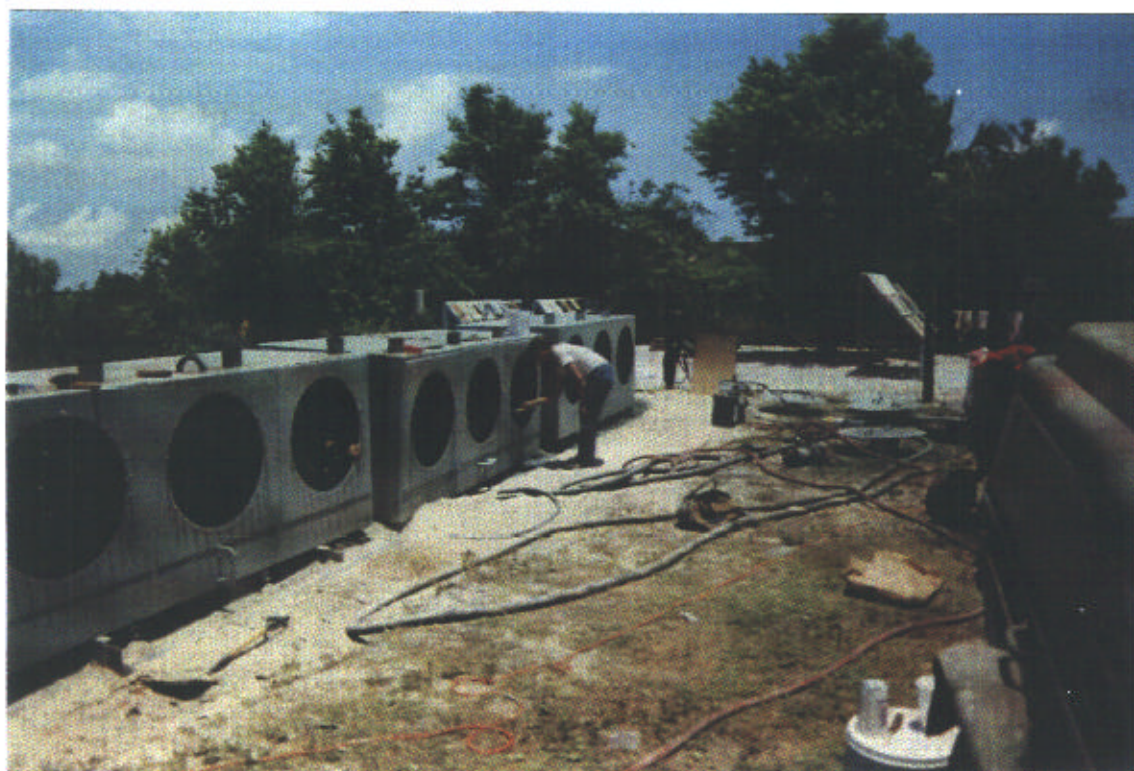
PHOTOGRAPH 1-TEST TANK ASSEMBLIES

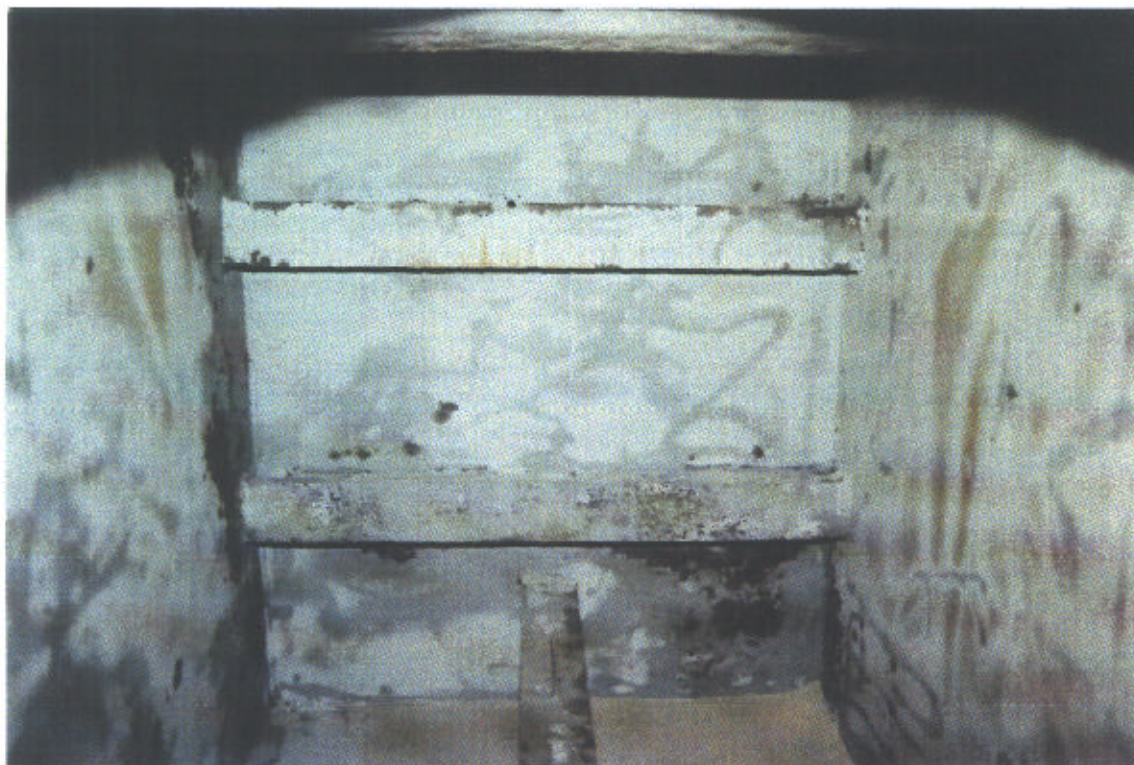
The chloride contamination of the Sweep Blast Cleaned (SP 7) surface was measured as being 8 milligrams per square meter. The results of the Sweep Blast Cleaned surfaces is shown in Photograph 3.

PHOTOGRAPH 3-SWEEP BLAST CLEANED SURFACE PRIOR TO COATING

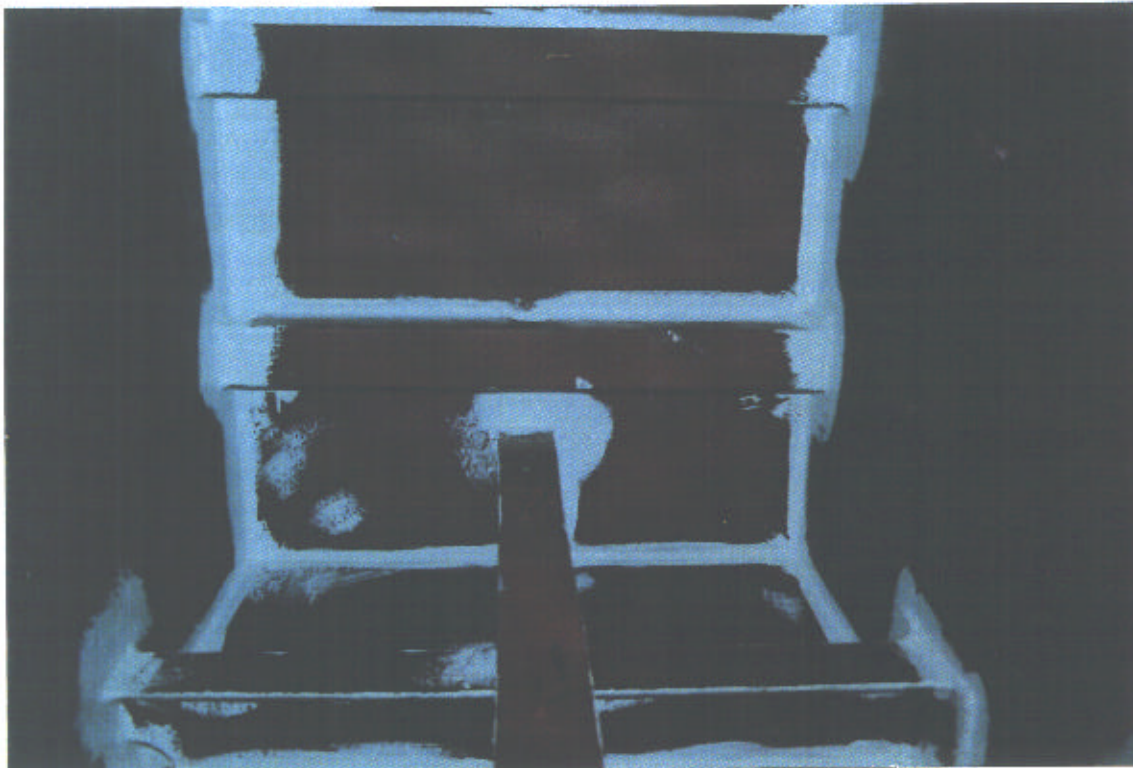
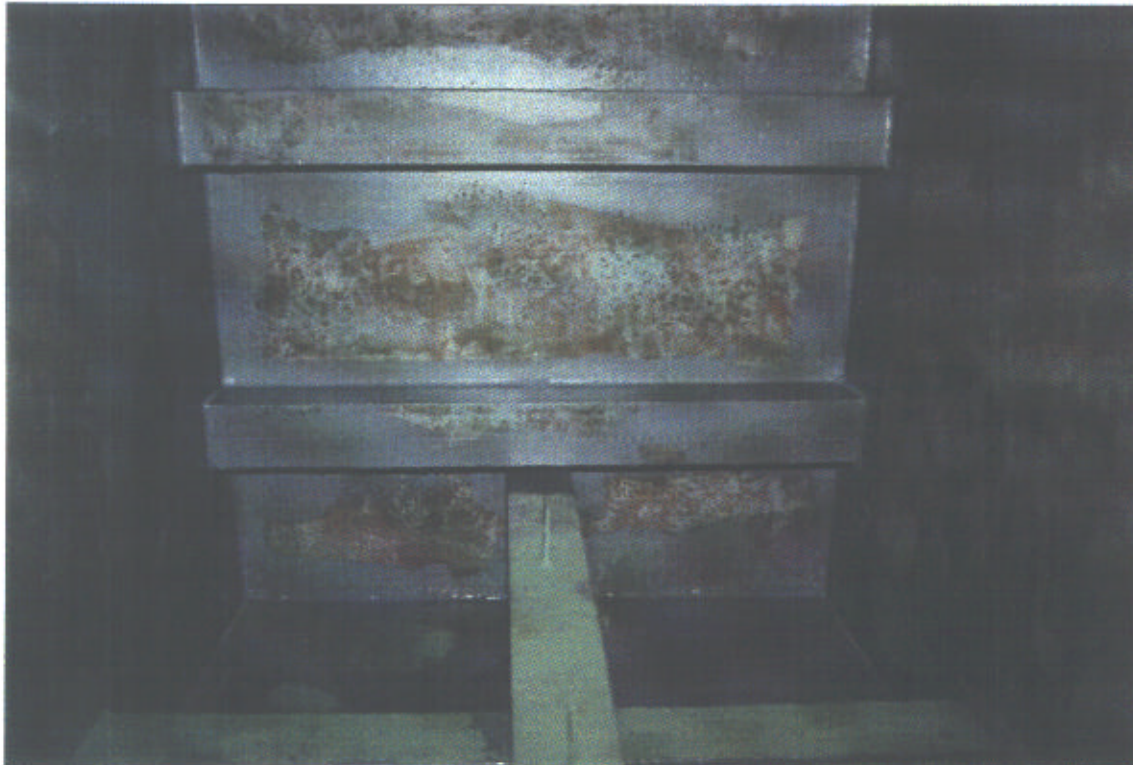
All coatings were applied with conventional pressure pots and spray guns. All welds and sharp edges were stripe coated before the application of the first coat and between coats. See Photograph 6. Sharp edges were not rounded.

PHOTOGRAPH 6-STRIPE COATING BETWEEN COATS

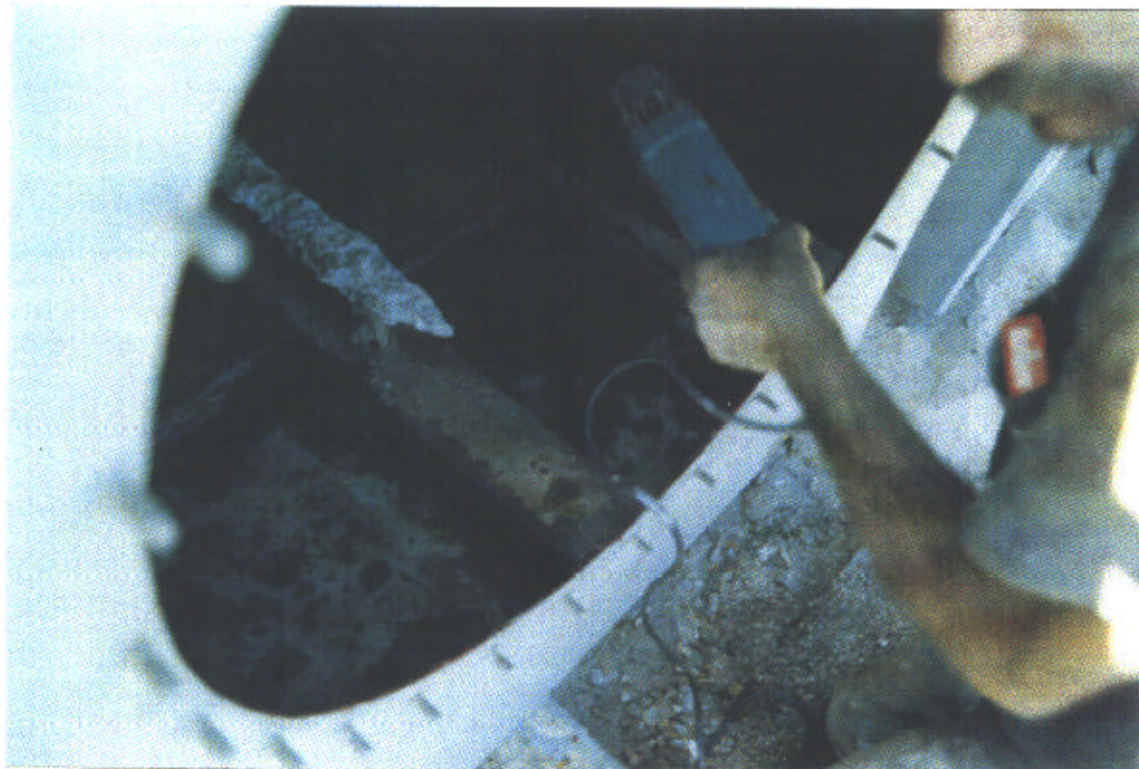
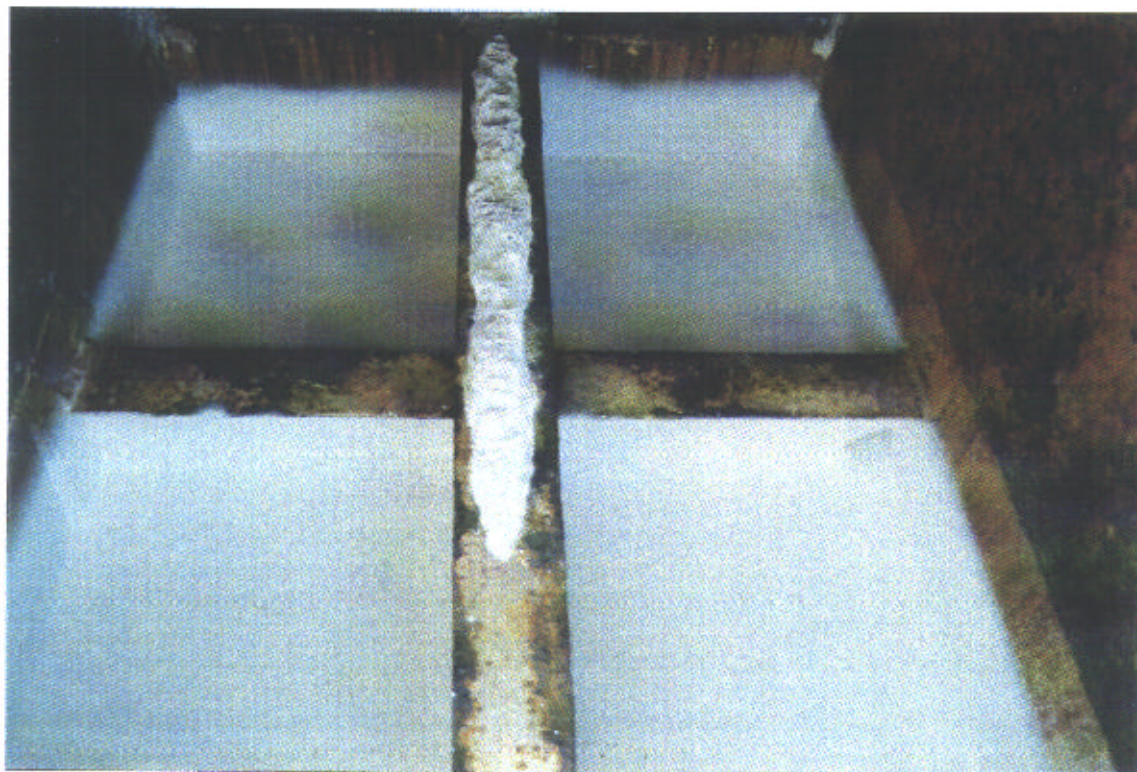
PHOTOGRAPH 7-REPAIRED BOTTOM OF PARTIALLY COATED TANK WITH CP
